The REMR Bulletin

News from the Repair, Evaluation, Maintenance,
and Rehabilitation Research Program

VOL 4, NO. 3

Chemical Grout Used to Stop Water Leakage in Control Towers and Conduits

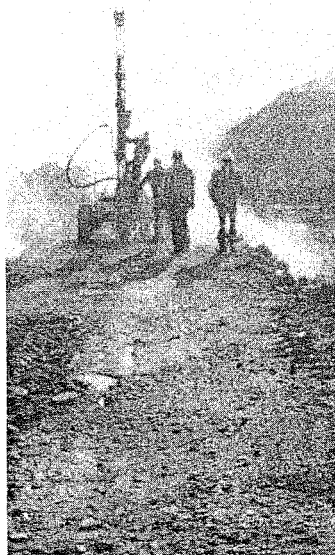
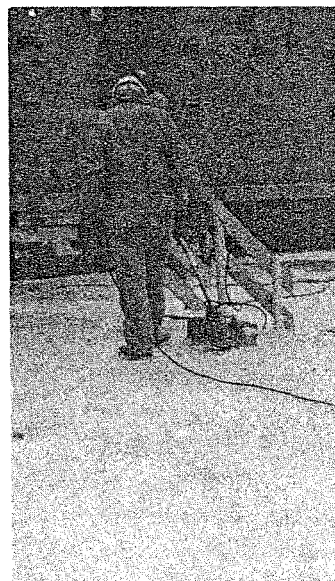
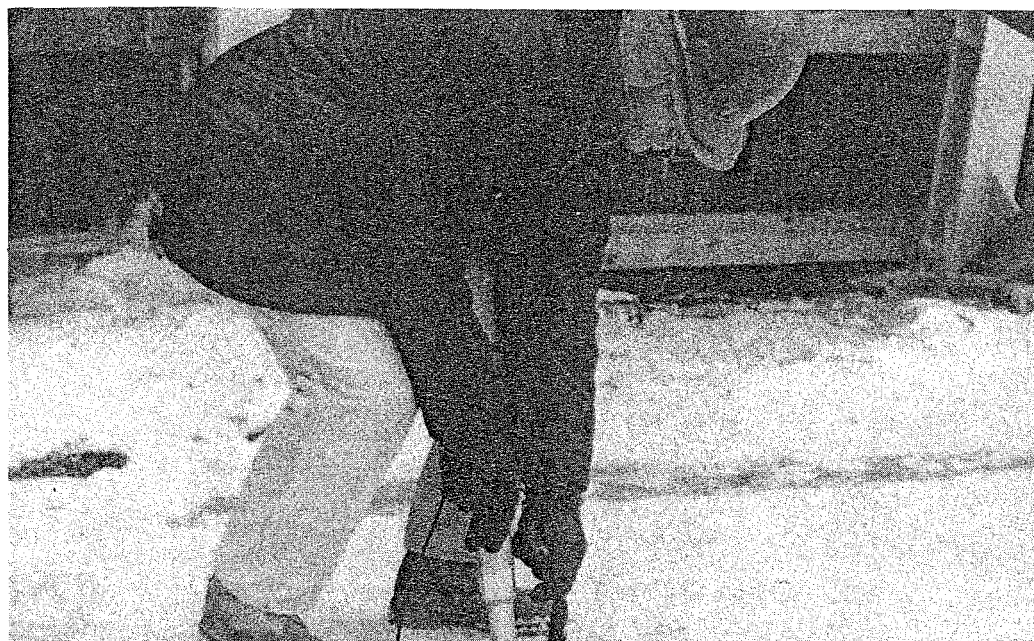
Use of pulse echo impact hammer and transducer.

As the testing progressed, areas of suspected voids were drilled and grouted. In general, the condition of the foundation material investigated was good. The presence of unconsolidated materials and voids from 1 to 6 inches in depth were scattered and isolated, making the probability of locating all voids by a drilling program alone quite low. As a measure of the testing program's effectiveness, the drilling and grouting contractor

attempted to correlate the NDT results with the results of the drilling. Reported correlation was over 80 percent.

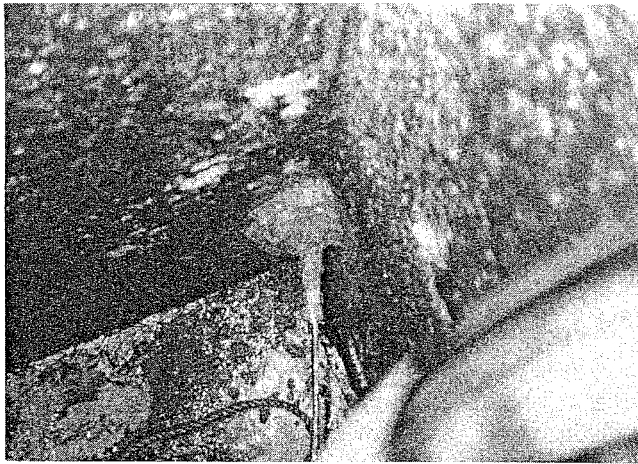
Repair work began at the leakage at elevation 512 feet. A 12-inch length of 1/2-inch copper tubing was inserted approximately 6 inches into the hole. Oakum was then packed around the tubing to divert most of the leakage through the tubing. Water Plug, a fast-setting hydraulic cement manufactured by Thoro Systems of Miami, Florida, was then kneaded into a fairly stiff ball and packed around the copper tubing three times before all of the leakage was diverted through the tubing (Figure 1). The

Figure 1. Injection port; copper tubing with valve installed in wall with oakum and hydraulic cement packed around the tubing; Barren River Lake.

Two gallons of TACSS-020 NF was mixed manually in the pump bucket with 10 percent C-852 accelerator to obtain a minimum gel time of 4 minutes 30 seconds at the given water temperature. To ensure that water did not enter the open end of the hose or the pump, the cutoff valve on the end of the copper tubing was closed before the pump hose was attached, and a small amount of pressure was applied before the valve was opened and the grout pumped into the void. Bubbles around the port indicated the grout was reacting. The valve was closed after approximately 10 to 15 minutes gel time and the hose was disconnected. After an hour, the tubing was cut off flush with the wall. No leakage was noted after repair.

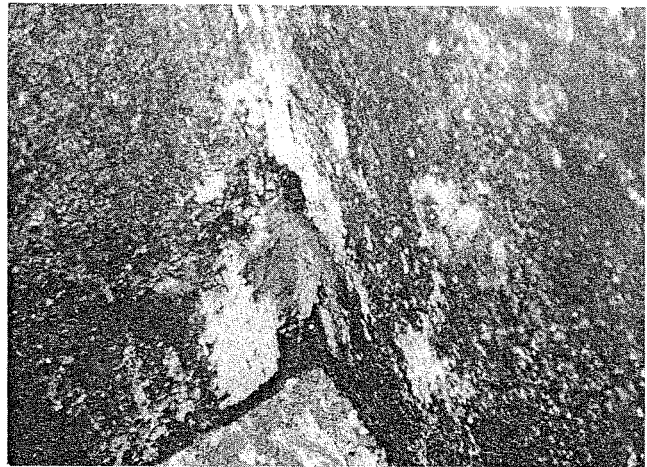
disconnected. After an hour, the tubing was cut off flush with the wall surface. No leakage was noted after the repair (Figure 2).

Figure 2. Repaired area at Barren River Lake.

The tubing and Water Plug were removed, and the tubing was reinserted. Oakum packed around the tubing stopped the leakage, and the grouting operation was resumed. Approximately 2 gallons of grout was pumped into the void. The grout was allowed 10 to 15 minutes to gel before the pump hose was

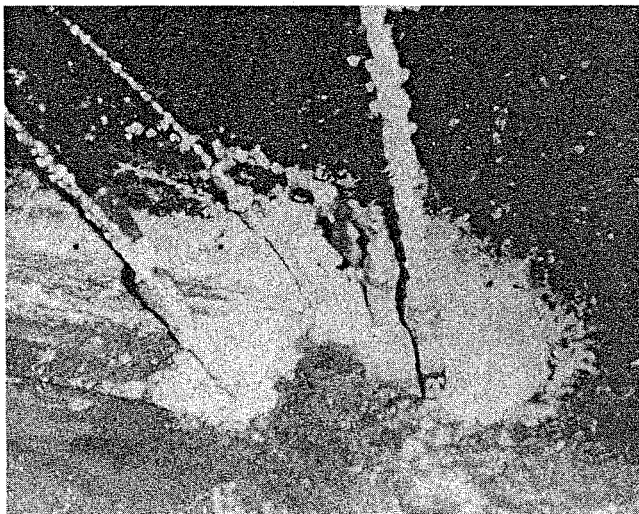
Port tubings inserted near full depth of each hole provided a longer flow path, thereby increasing the time the grout had to set before exiting the concrete. Oakum packed into cracks and holes around the ports directed the majority of leakage through the ports. This process had to be done in a persistent manner, since pressure increased as each small quantity of flow was shut off. At times one closure would cause a previously sealed area to leak again. After the packing of the oakum was completed, the effectiveness of the packing was checked by closing all five valves. Preco Plug packed into the cracks around and over the oakum provided additional resistance against blowout (Figure 3).

Figure 3. Close-up of four ports in monolith No. 2 with Preco Plug applied.

The leakage at Buckhorn Lake Dam was eliminated in July 1986. Injection ports, consisting of a 1/2-inch copper tubing with a cutoff valve and a fitting to attach to the delivery hose, were fabricated by District personnel. Two holes, into which ports were installed, existed prior to this repair effort. One hole drilled in 1962 penetrated the waterstop approximately 15 inches into the concrete. The other hole, eroded by the flow of the water over the years, had increased to the point that the 1/2-inch copper tubing could be inserted 18 inches or more. Three 3/4-inch-diameter holes were drilled to relieve pressure during the sealing process. These holes were drilled to the depth of the waterstop, about 6 inches, but did not penetrate it.

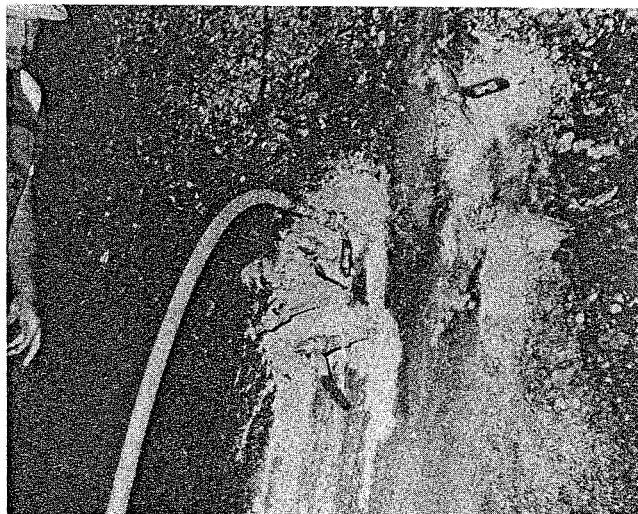
eroded hole. A number of extremely small seeps that existed prior to the start of the grouting operation stopped after 2 to 3 minutes with grout solidifying on the interior wall at some of the seep locations. After all of the approximately 2-1/2 gallons of grout mix had been pumped, the port valve was closed to allow time for the grout to react and solidify (Figure 4). Another 2-1/2 gallons

Figure 4. Allowing time for grout to gel prior to removal of injection hose; Buckhorn Lake.

After the Preco Plug had set for about 20 minutes, 2-1/2 gallons of TACSS-020 NF mixed with 5 percent of C-852 accelerator was pumped through the open valve of the port occupying the

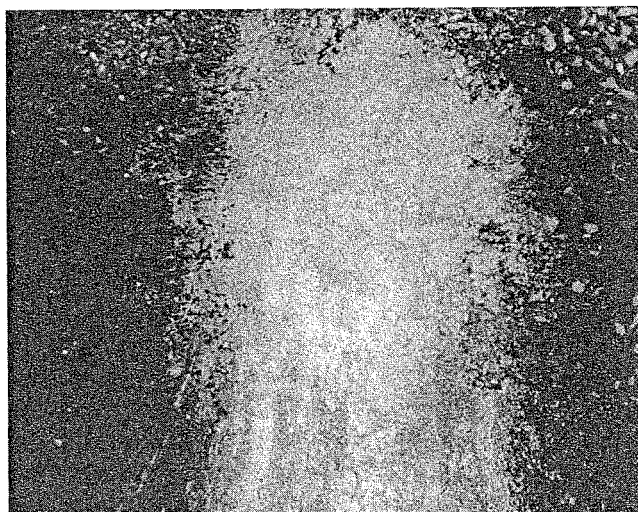
of mix was prepared; pumping into the single downstream port was initiated, but no grout was taken. With valves closed and hose removed, the injected grout was allowed to gel for an additional 30 minutes. Ports were then cut off slightly below the wall surface and the projecting oakum was removed. Preco Plug was spread over the work area to form a protective seal (Figure 5).

Figure 5. Preco Plug seal; Buckhorn Lake.

The work was inspected after about 2 years of normal discharge operation with no leakage noted.

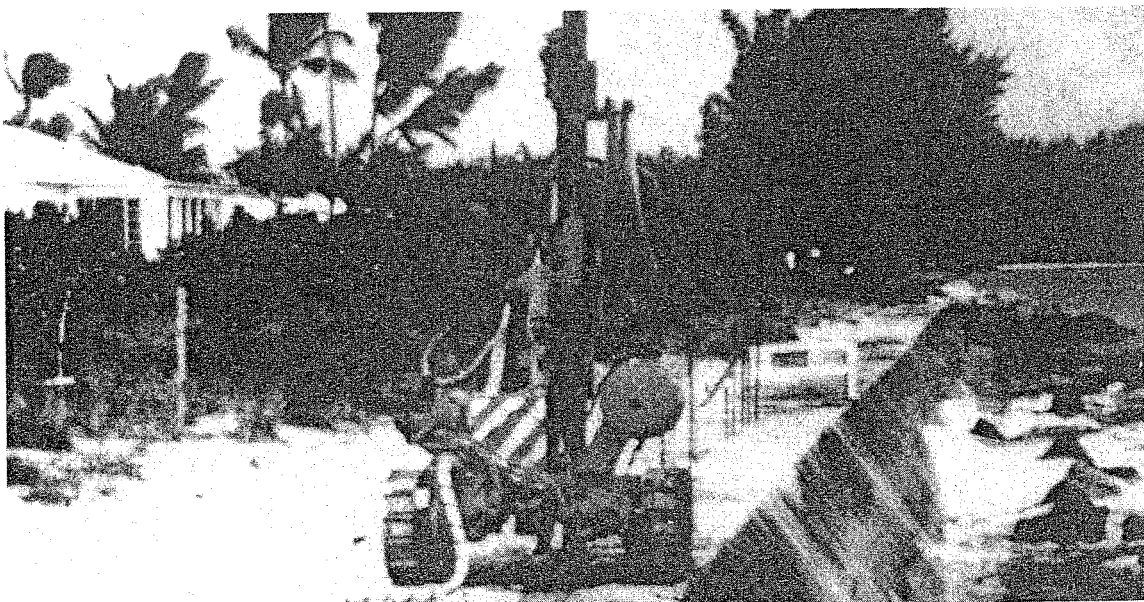
Figure 2. Drill rig atop Palm Beach Harbor South Jetty. Grout injectors were installed as the rig advanced in preparation of grouting operations.

In 1985 the south jetty of the Palm Beach Harbor, Florida, project was grouted to eliminate a shoal that progressed channelward from the south jetty and interfered with navigation (Figure 2). A grout curtain 800 feet long, 6 feet thick, and extending in height from -10 feet mean low water to the jetty crest was created. In estimating the quantity of grout needed, planners assumed 30 percent of the space to be grouted was void volume. Experimentation with various grout compositions and hole spacing revealed the best grout mixture to be 1 cubic foot of cement to 10 cubic feet of sodium silicate to 9.5 cubic feet of water. An accelerator was not needed because of the action of the salts in

the ocean water that saturated the sand into which the grout was injected. Injection was through 2-1/2-inch drill casings. Final hole spacing was 3 feet center-to-center; the pattern of hole locations was linear. A better buildup of grout was obtained by staging the grout in an alternate-hole sequence. The grout take was from 2 to 4 gallons per minute for 10-minute durations with each vertical foot of the injector location.
